Southern Regional Building Control Committee

Achieving NZEB In Homes

Typical Pitfalls in NZEB Compliance

(Building Control Inspections)

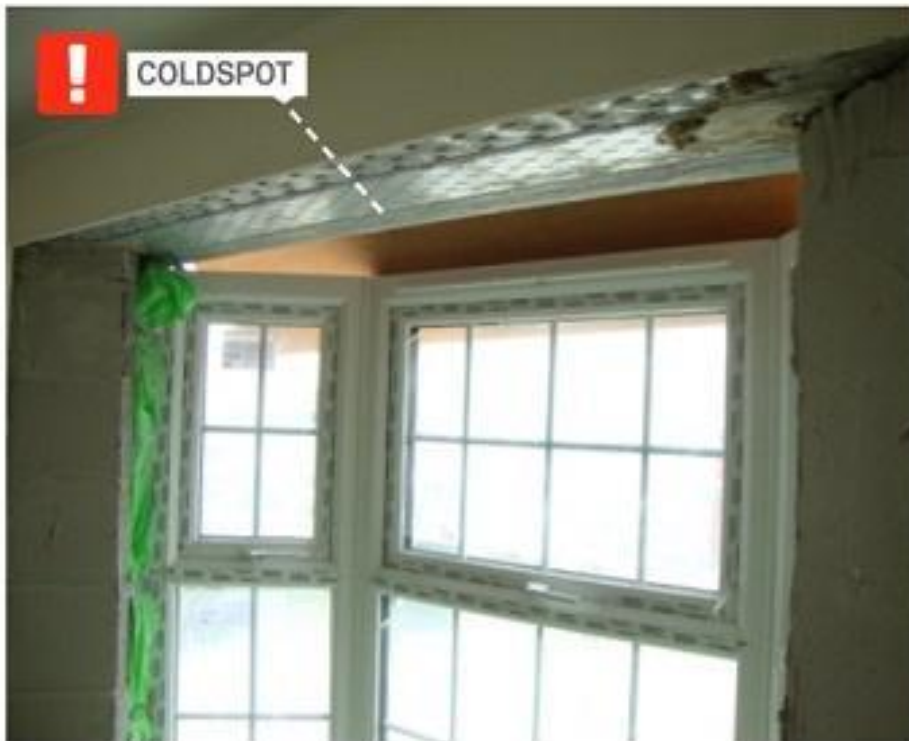
PROBLEM TO AVOID

COLD BRIDGING

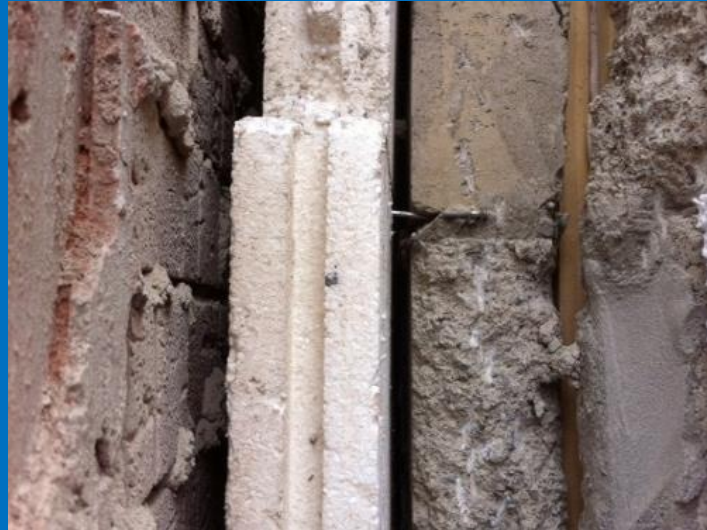
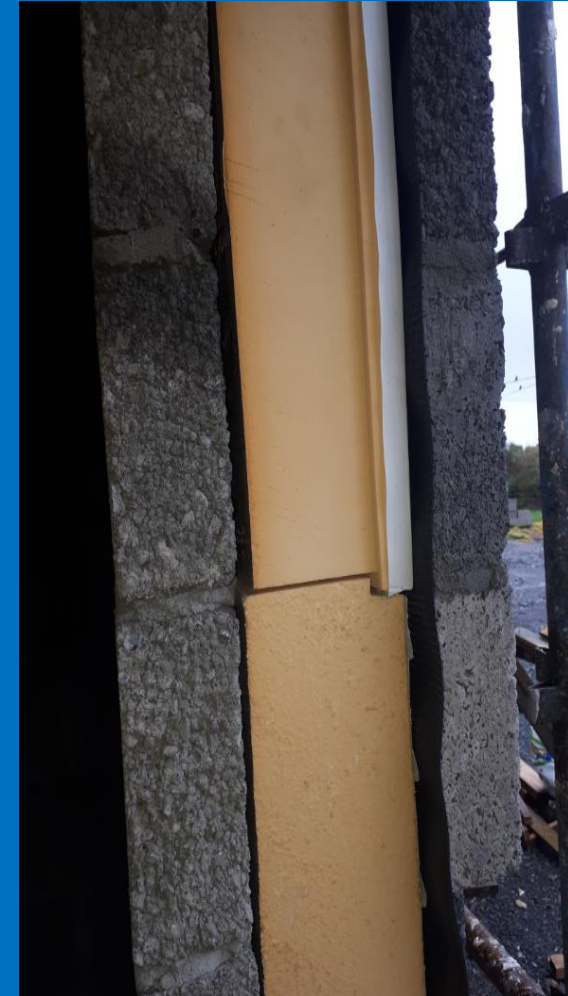
Thermal looping can occur where insulation boards are not fitted tightly to the inner leaf of blockwork.

Where this occurs, it can have a detrimental impact on the u-value achieved.

A 10mm gap can reduce the u-value by up to 92%.

$0.18\text{W/m}^2\text{K}$ with 10mm gap = $0.34\text{W/m}^2\text{K}$

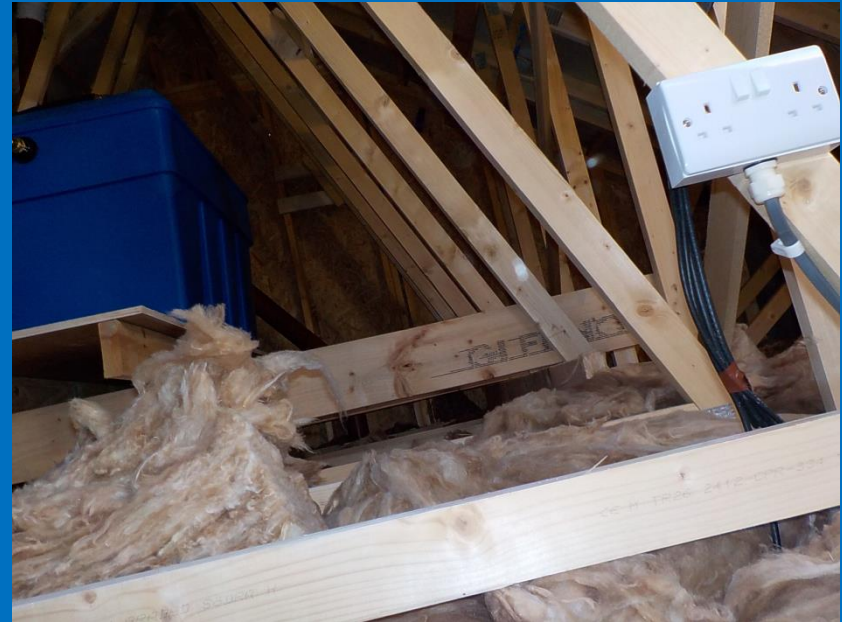
- U-value of $0.16 \text{ W/m}^2\text{K}$ required to roof
- Large depth of insulation as a result, this raises the height of the water storage tank making it difficult to ensure continuity of thermal envelope.
- Where the depth of insulation does not facilitate tenting up to the tank insulation—the ceiling should be insulated and the tank insulated separately – ie insulation to the underside of the tank.

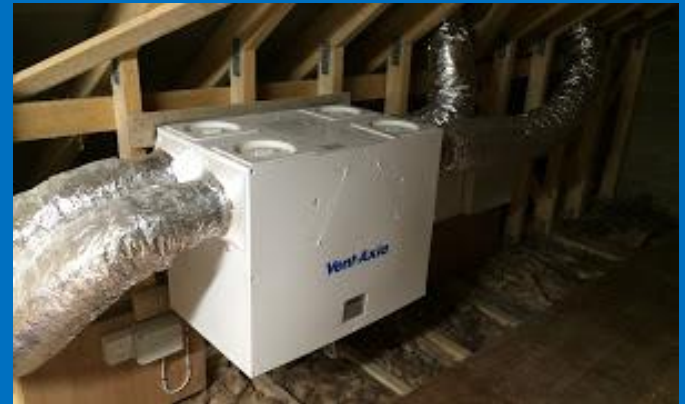
Appendix B5 – Technical Guidance Document L 2019

- As the increased depth of insulation will obscure the location of joists it's important to consider safe access to the storage tank and to other services within the attic space such as a MVHR unit.
- Insulated walkways are therefore required to these services – these should be detailed at an early design stage to avoid issues on site.

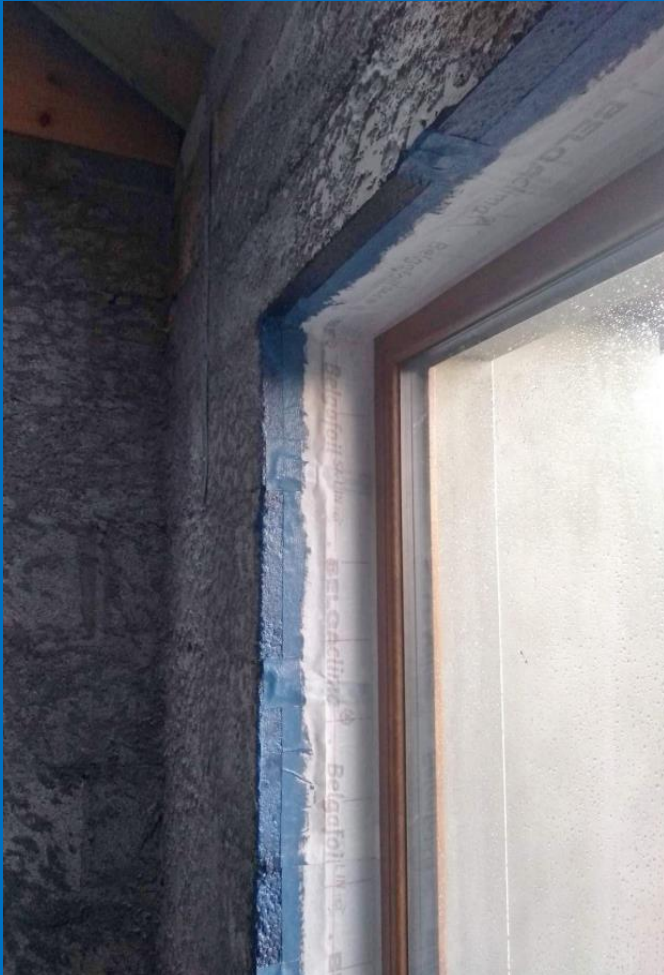
Correct tape used and sealed with airtightness paint

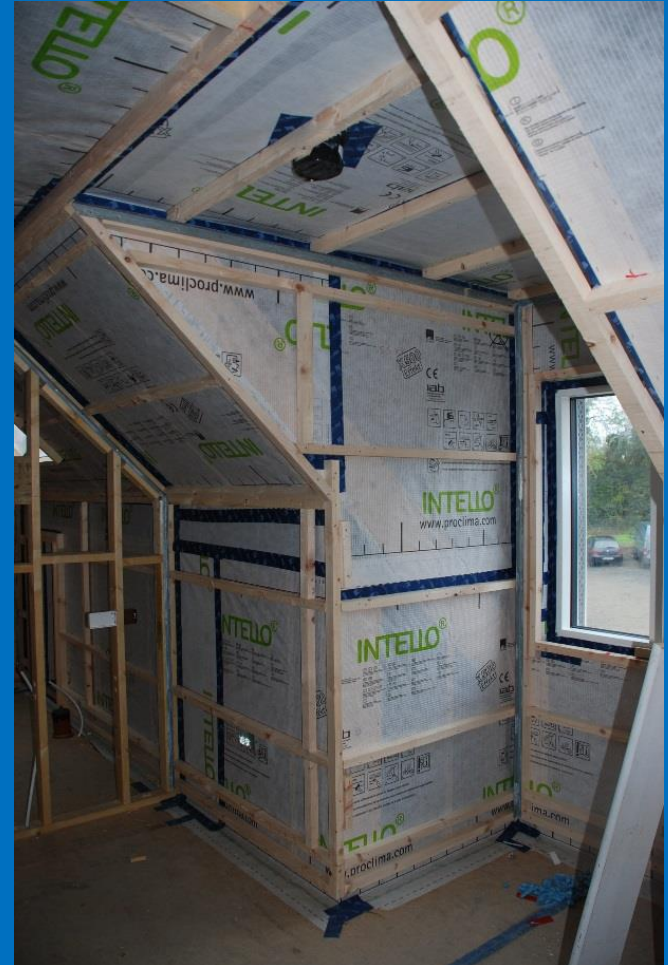
Well sealed membrane to dormer roof

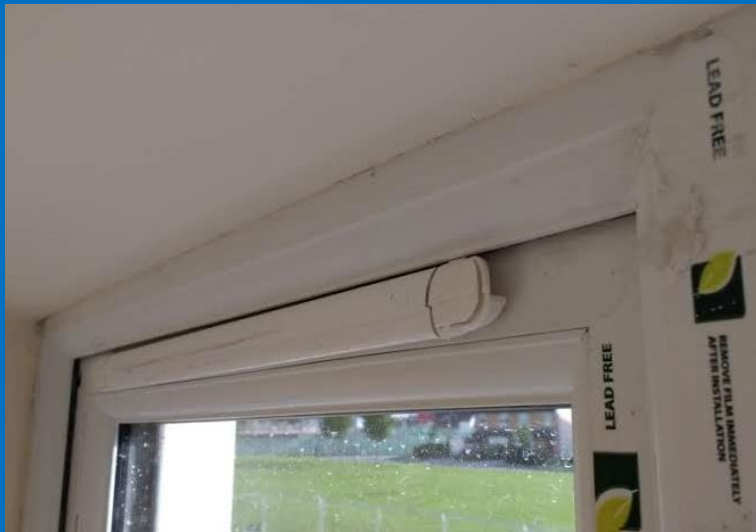
Window Trickle Vent

Pro: Slim / Neat, work with MEV systems

Con: May not achieve natural ventilation requirements

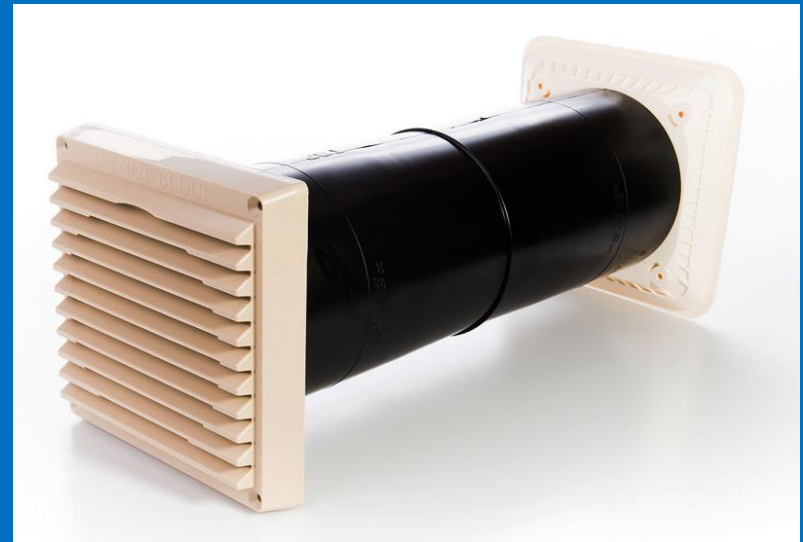
Wall Vent

Pro: High equivalent area values

Con: May cause draughts (consider the layout of the room / product selected)

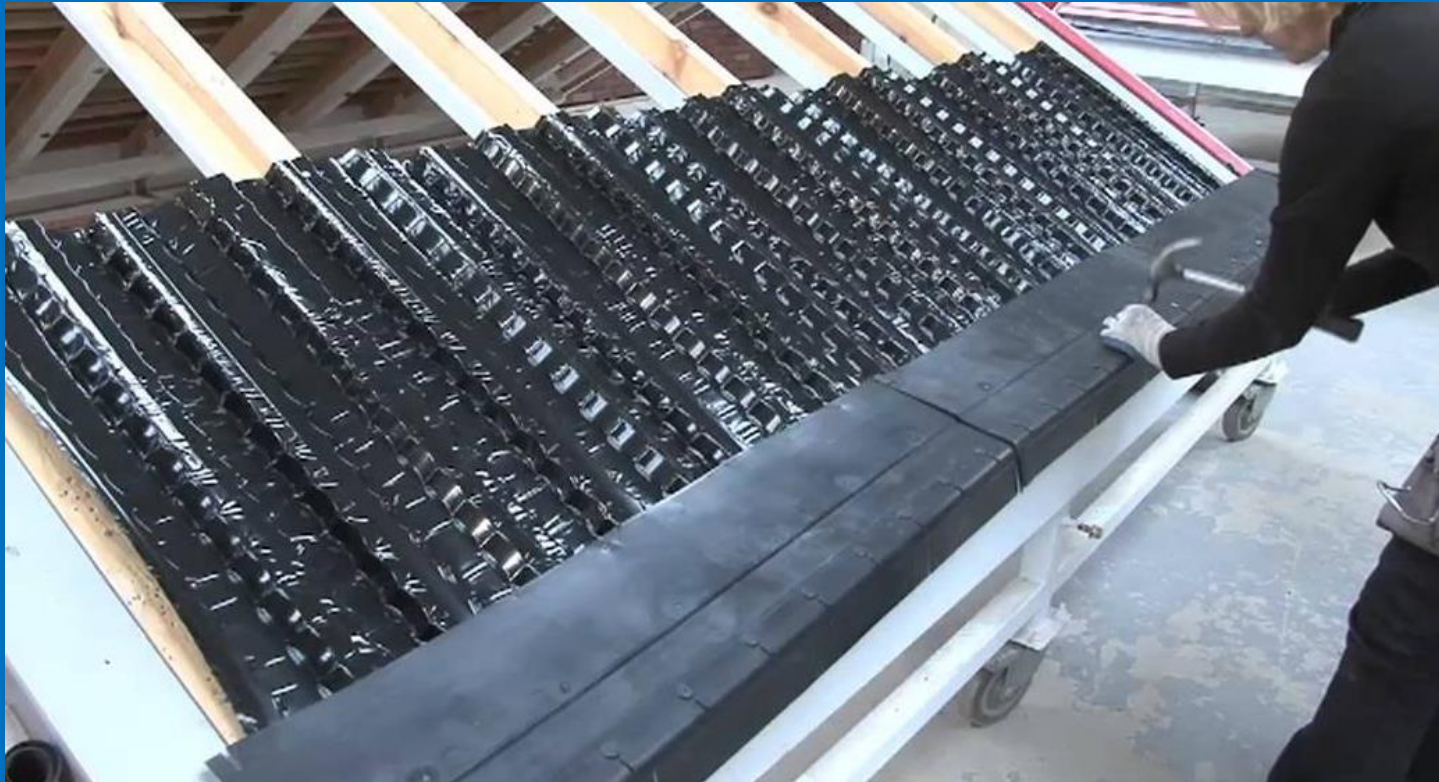
- Eaves Ventilator – Ensure it is not pulled tight when installing.
